# ECM Calibration: Enhancement to Shifting Performance

Service Category Drivetrain

Section Automatic Transmission/Transaxle

| YEAR(S) | MODEL(S) | ADDITIONAL INFORMATION |
|---|---|--|
| 2010 | GX460 | Transmission(s): 6AT-F<br>VDS(s): BM7FX, JM7FX |

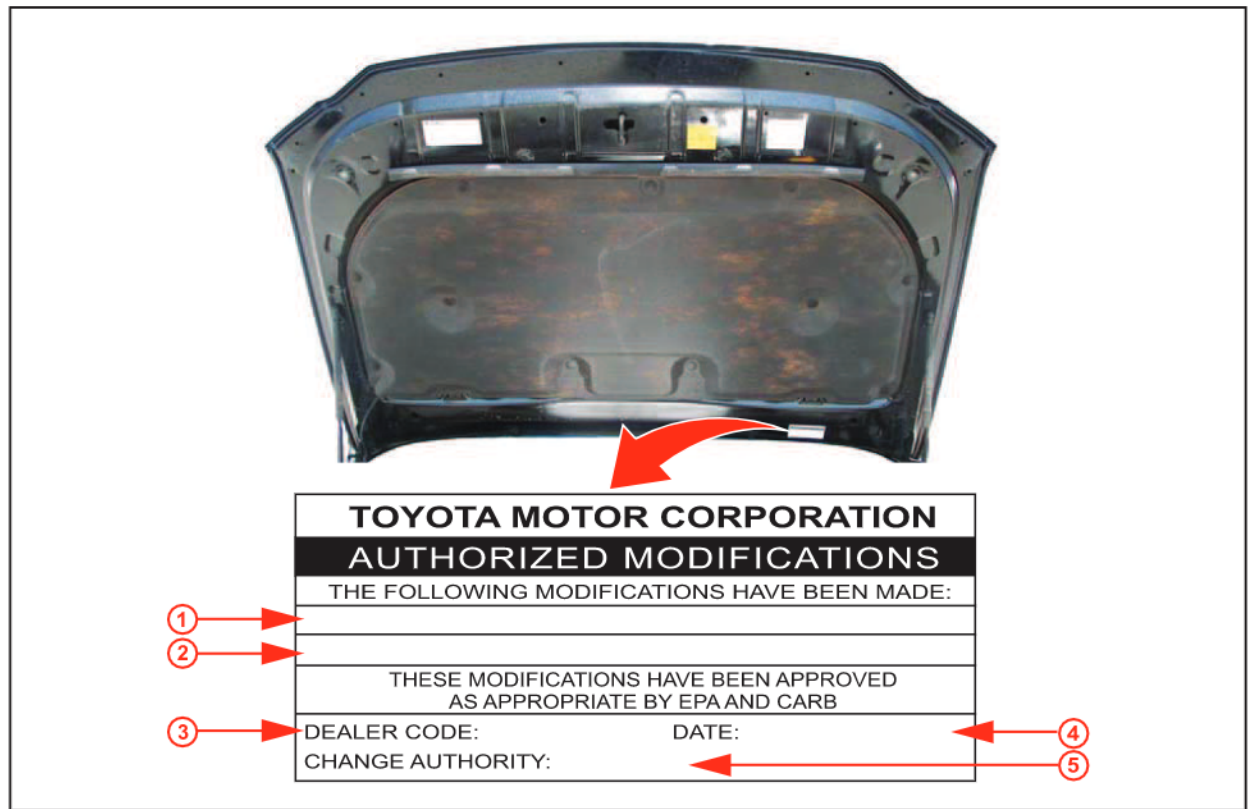
Figure 1. Location of Authorized Modifications Label on 2010 GX 460

1. Test drive the vehicle and confirm there is a harsh shift on acceleration below 20 mph, and or excessive lock-up operation at freeway speeds about 50 – 60 mph.
2. Check for the Authorized Modifications Label affixed to the vehicle in the location shown in Figure 1. Confirm if the ECM (PCM) calibration has been updated. If the calibration ID listed is NOT the latest ECM (PCM) calibration — go to step 3.

- Install the Authorized Modifications Label.
  - Using a permanent marker, enter the following information on the label:
    - ECM part number [Refer to the **Parts Information** section for the **CURRENT PART NUMBER**]
    - Calibration ID(s) [Refer to the **Calibration Identification Chart** for the **NEW CALIBRATION ID**]
    - Dealer Code
    - Repair Date
    - Change Authority [**This TSB number**]
  - Affix the Authorized Modifications Label to the vehicle at the location shown in Figure 1. The Authorized Modifications Label is available through the MDC, P/N 00451-00001-LBL.
