Technical Bulletin

Model
911 C2/C4
Turbo

Engine Cooling Fan Hub

Number
9306

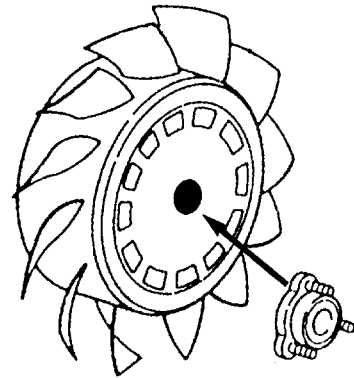
Repair Information: The hub can be removed and installed using a normal shop press. The hub should be used when a vehicle is being repaired for a noisy or damaged fan bearing or fan hub.

The fan hub can be installed on engine cooling fans with the following part numbers:

Parts Information: Engine cooling fan hub 964 106 051 30
